Dream Home Inspections

Inspection Report

123 Dream Home Way
Frisco, CO
80443

Inspection date: 3/28/2014

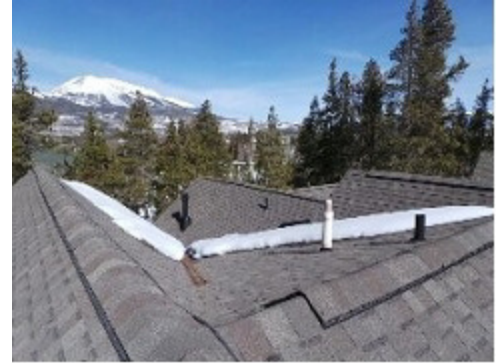
Roof

Condition: Poor-Out of Condition

The roof is the main source for water damage and can be an expensive repair. Inspection includes describing the roofing material, its construction, condition, and checking the interior of the building with an Infrared camera for existing water intrusion.

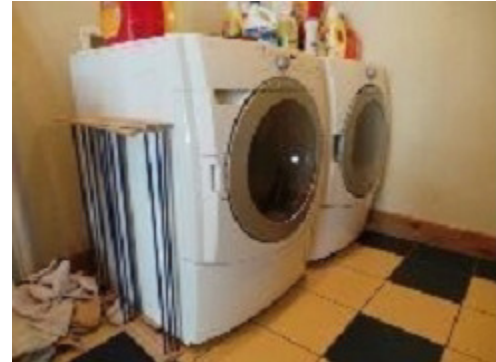
Washer/ Dryer

Condition: Broken-Not Functioning

Most homes in Summit County come with a washer and dryer. This means that existing hoses and ventilation are kept in place when they are normally replaced. The washer and dryer are operated and the connections inspected.

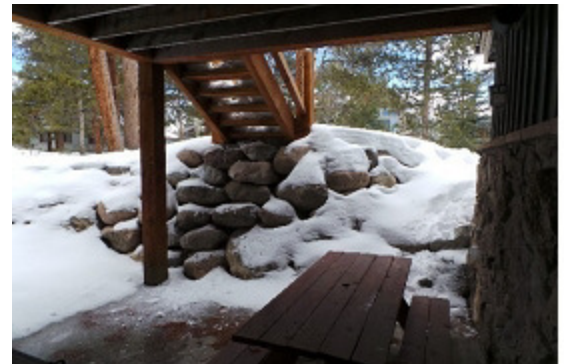
Retaining wall

Condition: Repair-Adjustment

Retaining walls and grading of the property are inspected and reported when they may adversely affect the structure, especially due to moisture intrusion. This rock wall turned the back patio into a catch basin that flooded the basement during a heavy rain storm.

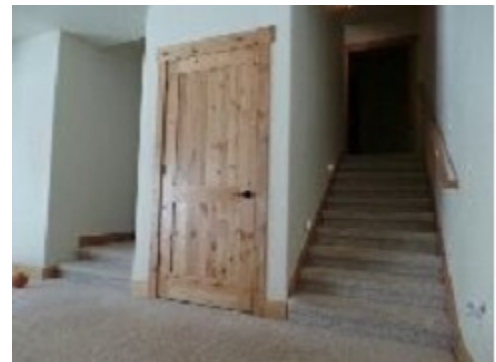
Stairs

Condition: Safety Concern

Stairways are the sites of a surprising number of injuries. This is because of steps that are loose and of different heights. There may also be missing, loose or non standard handrails. Homeowners may not even be aware that their stairs are dangerous because they get used to them!
